## Road and Railroad Crossing Inventory

Little Coulee

U.S. Department of the Interior  
Bureau of Reclamation  
Great Plains Region  
Dakotas Area Office

September 2005

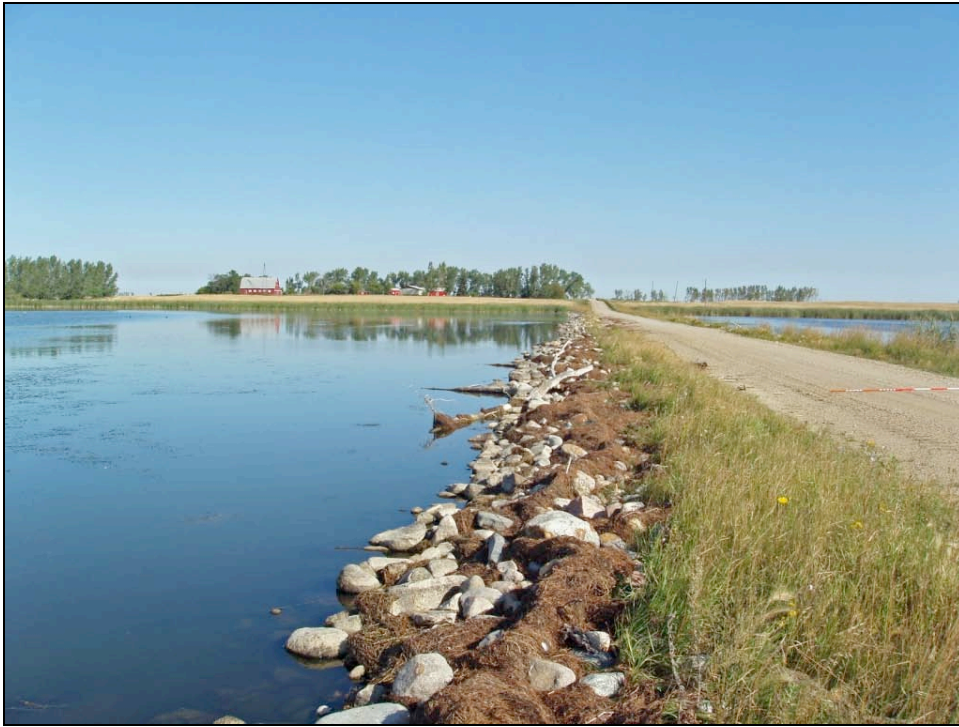
L1 Upstream side of undetermined CMP, in undetermined condition, road going north & south, Silver Lake (09-7-05), Section 2 & 3, T154N, R67W, N 435563.93, E 2306651.80, elevation 1439.9 @ water edge.

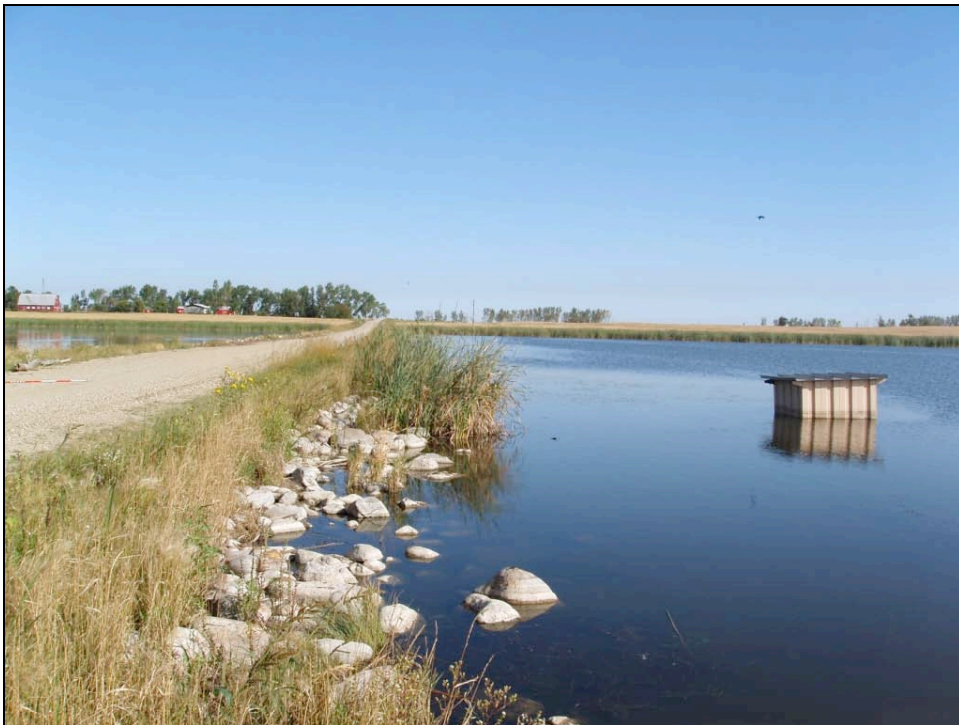
L1 Downstream side of undetermined CMP, in undetermined condition, road going north & south, Silver Lake (09-7-05), Section 2 & 3, T154N, R67W, N 435559.30, E 2306608.89, E 1439.8 @ water edge.

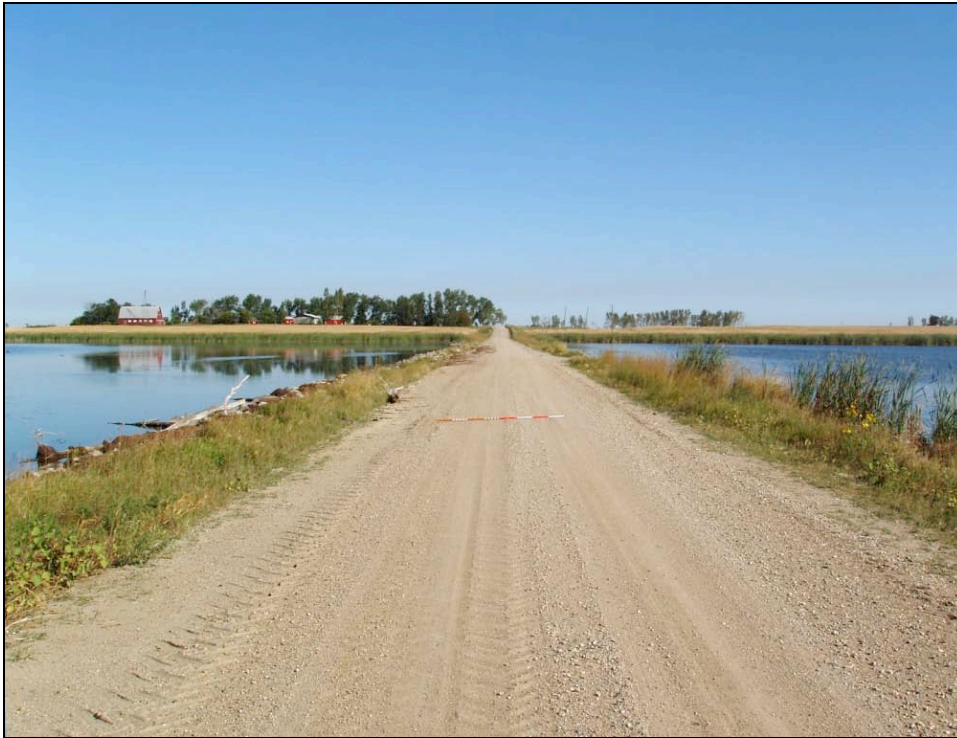
L1 Center of road crossing across undetermined CMP, looking north (09-7-05), Section 2 & 3, T154N, R69W, N 435563.44, E 2306632.09, elevation 1441.4 @ center of road crossing, above CMPs, top of gravel.

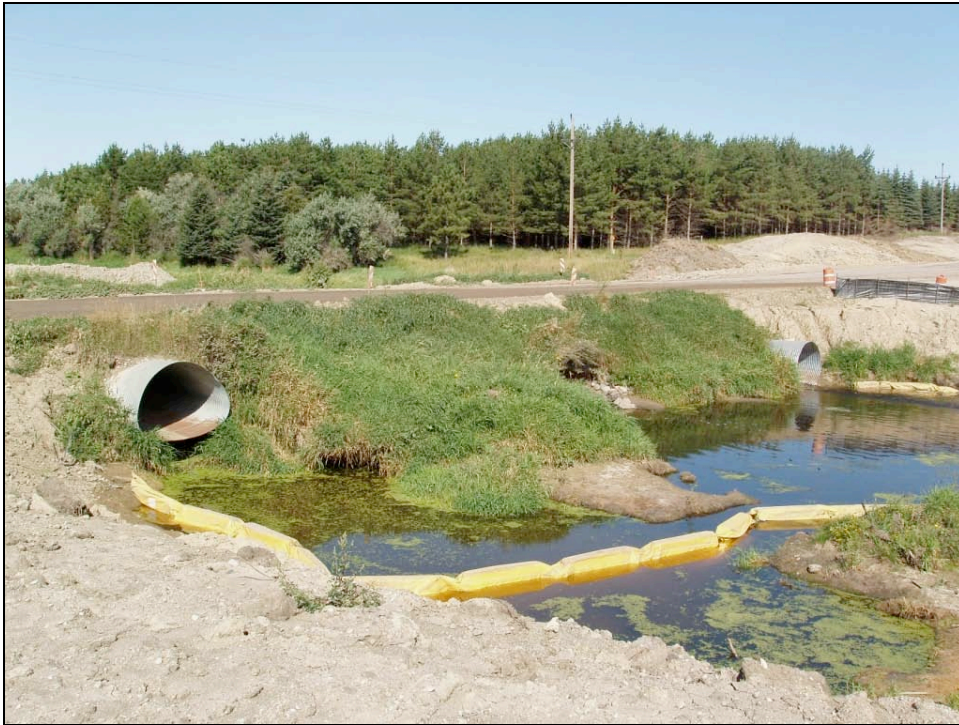
L2 Downstream side of three 60" CMPs in good condition, CMPs will be replaced with box culverts this year, 1.2 feet, 0.5 feet, & no water, from north to south (09-7-05), Section 32 & 33, T155N, R67W, N 442913.21, E 2295964.33, elevation 1442.5 @ invert of CMP, N 442880.66, E 2295955.00, elevation 1442.9 @ invert of CMP, N 442835.00, E 2295960.47, elevation 1445.4 @ invert of CMP.

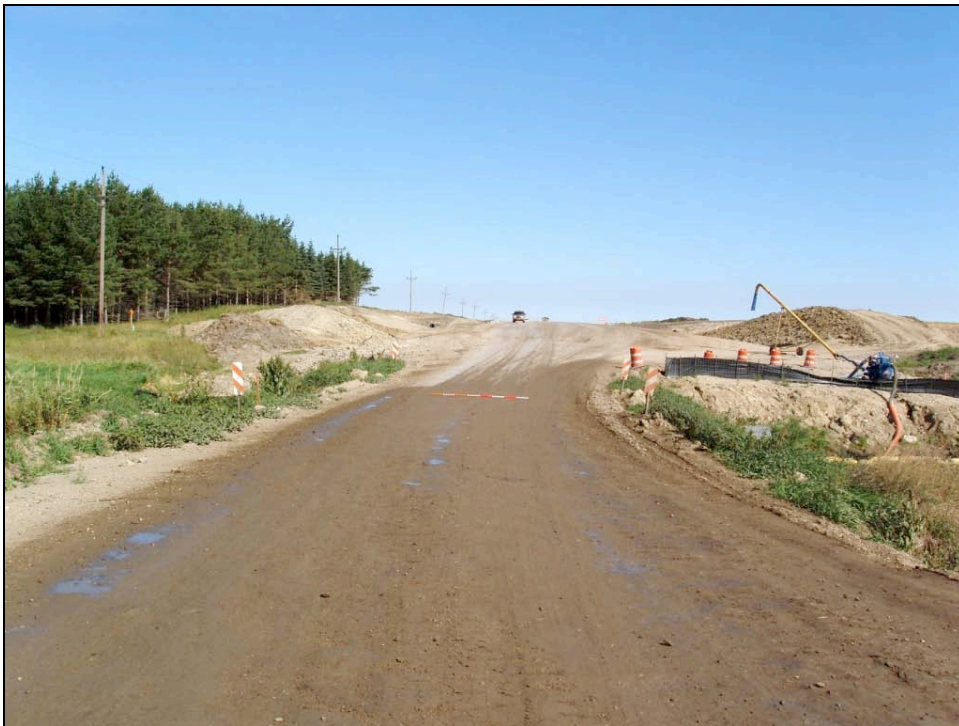
L2 Center of road, across three 60" CMPs, looking north, Section 32 & 33, T155N, R67W, N 442878.08, E 2295933.52, elevation 1452.8 @ center of road crossing, top of gravel. Center will change with the replacement of box culverts.

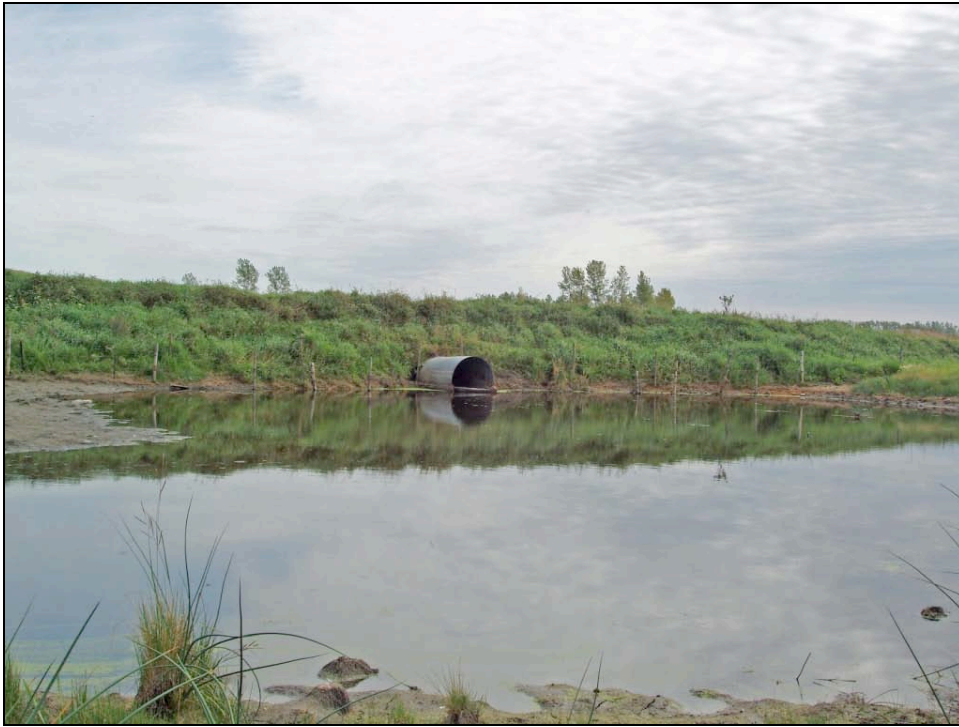
L3 Upstream side of one 60" CMP, in good condition, 1.3 feet of water (09-7-05), Section 30 & 29, T155N, R67W, N 444537.94, E 2290602.03, elevation 1454.2 @ invert of CMP.

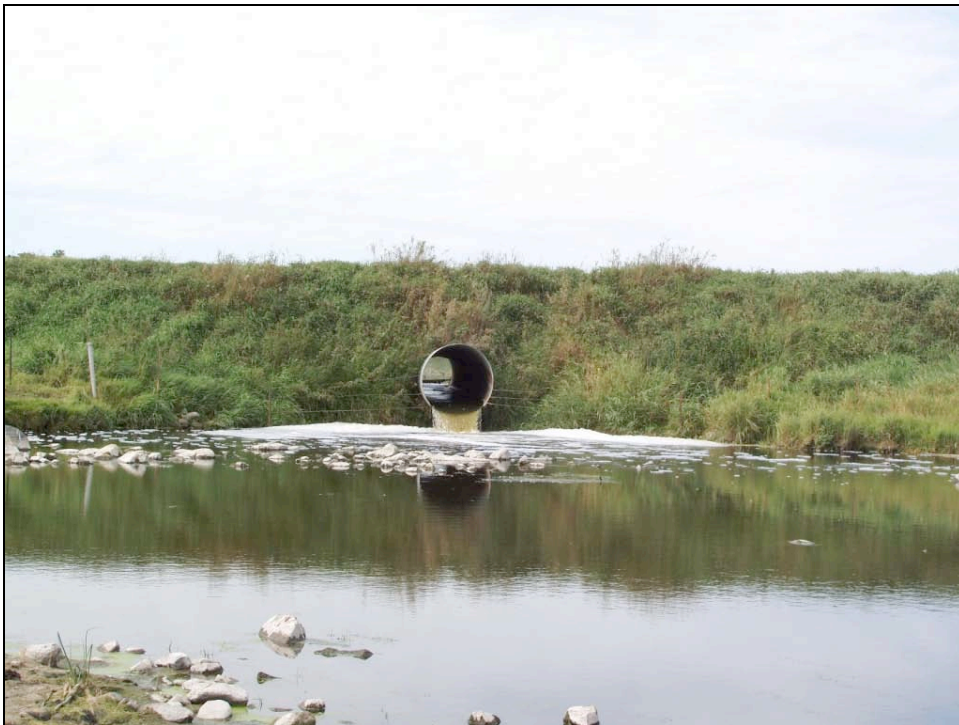
L3 Downstream side on one 60" CMP, in good condition, 1.0 feet of water (09-7-05), pipe above water level, Section 30 & 29, T155N, R67W, N 444542.51, E 2290662.61, elevation 1454.1 @ invert of CMP.

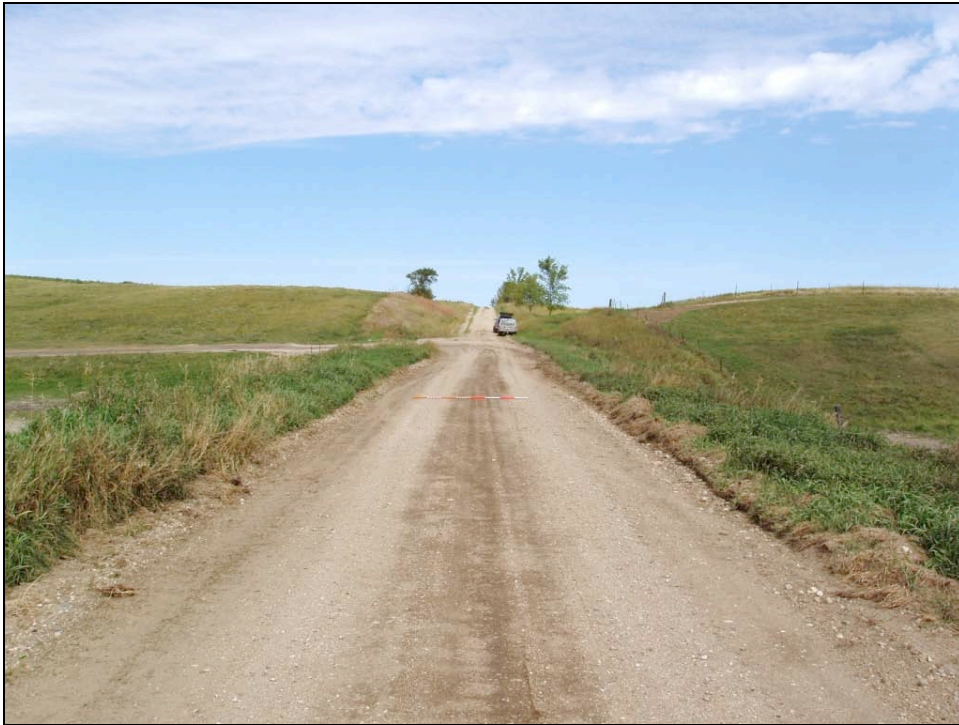
L3 Center of road crossing, across one 60" CMP, looking north,  
Section 30 & 29, T155N, R67W, N 444540.82, E 2290635.41, elevation 1464.3  
@ center of road crossing, top of gravel.

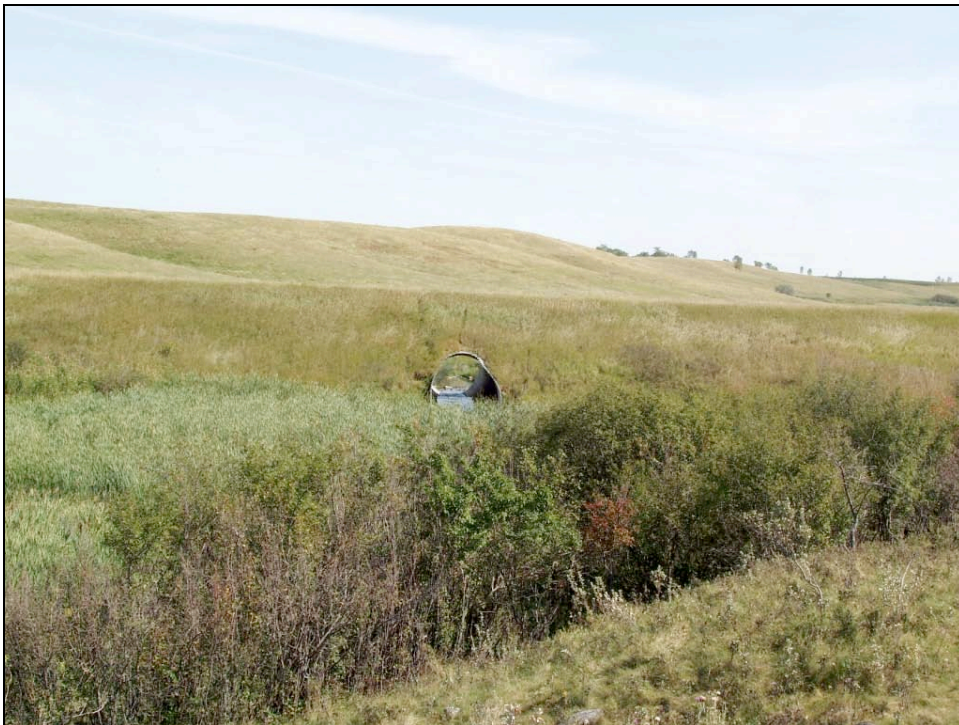
L4 Upstream side of one 180" CMP, in good condition, 1.0 feet of water  
(09-7-05), Section 25 & 30, T155N, R67 & 68W, N 446938.41, E 2285356.36,  
elevation 1465.7 @ invert of CMP.

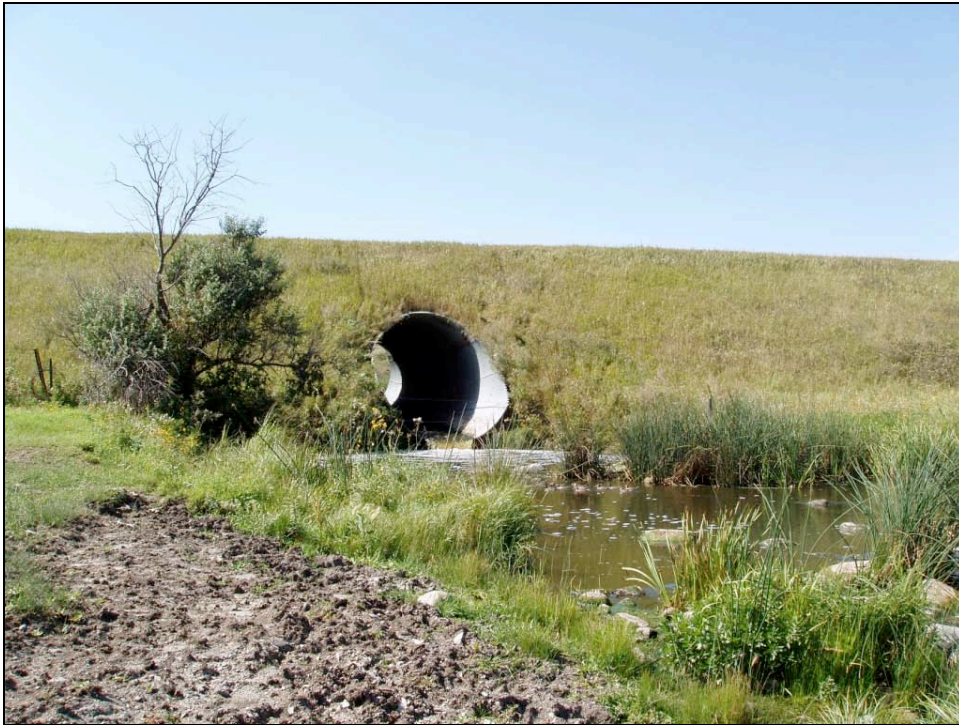
L4 Downstream side of one 180" CMP, in good condition, 1.1 feet of water (09-7-05), Section 25 & 30, T155N, R67 & 68W, N 446939.41, E 2285484.80, elevation 1464.7 @ invert of CMP.

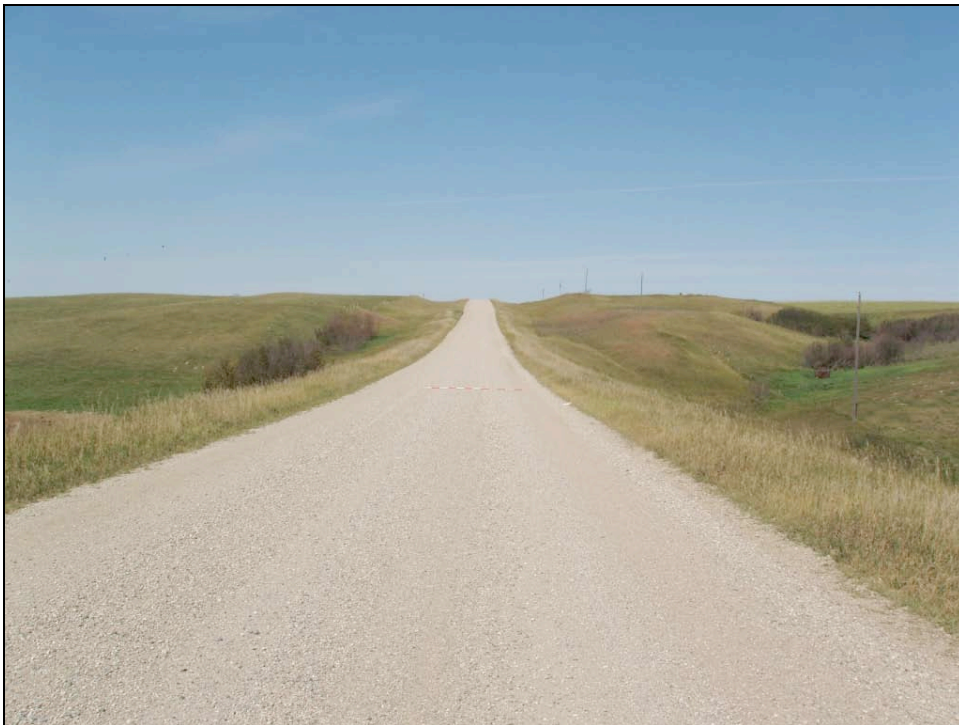
L4 Center of road crossing, across one 180" CMP, looking north, Section 25 & 30, T155N, R67 & 68W, N 446937.94 E 2285419.48. elevation 1491.9 @ center of road crossing, top of gravel.

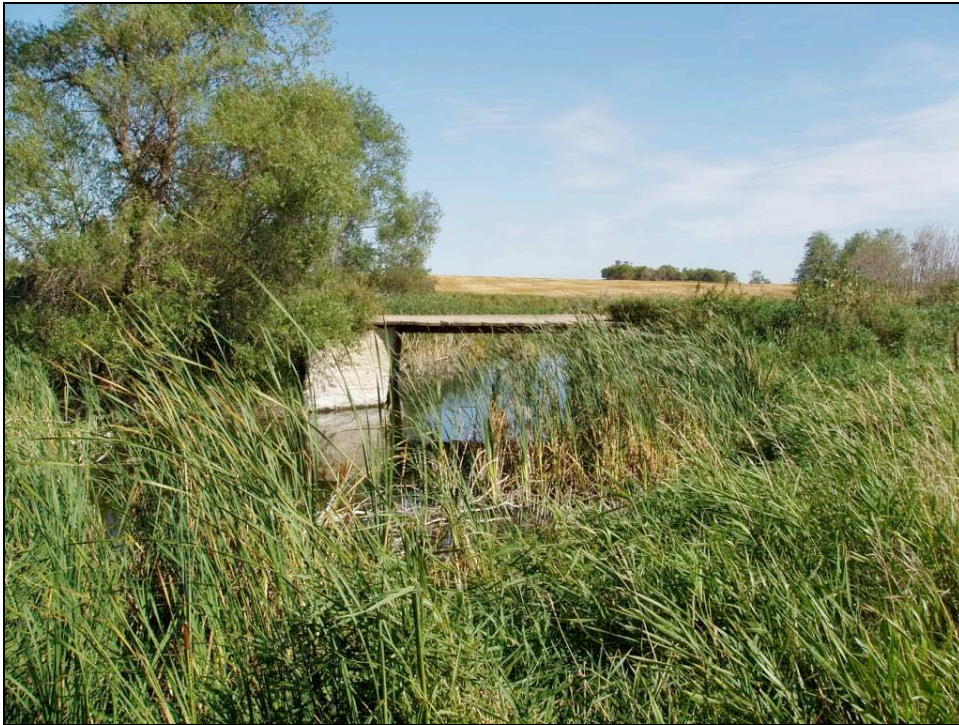
L5 Upstream side of wood & concrete bridge, in fair condition, 2.1 feet of water (09-7-05), Section 23 & 24, T155N, R68W, N 451045.74, E 2280055.78, coulee bottom elevation 1469.1 @ C/L of bridge.

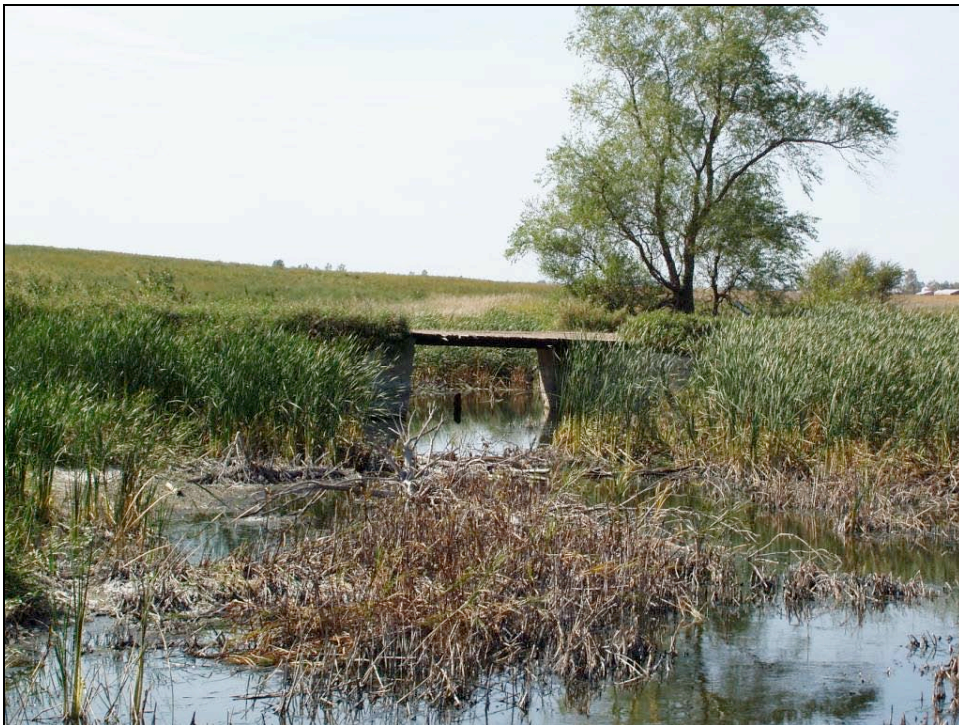
L5 Downstream side of wood & concrete bridge, in fair condition, 2.6 feet of water (09-7-05), Section 23 & 24, T155N, R68W, N 451046.08, E 2280079.67, coulee bottom, elevation 1468.6 @ C/L of bridge.

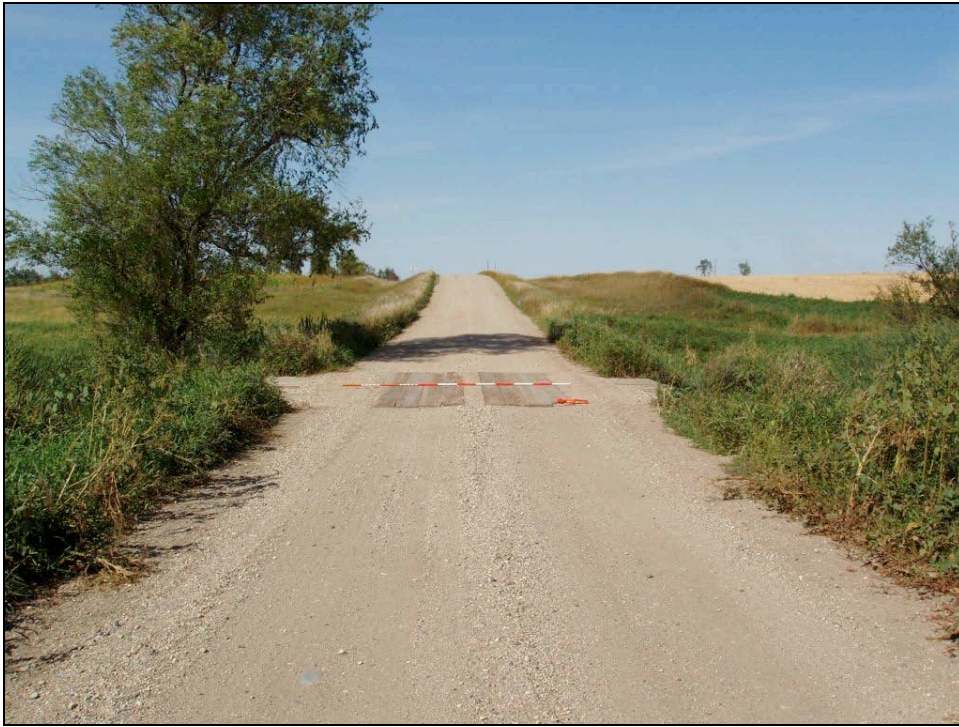
L5 Center of wood & concrete bridge, looking north, in fair condition, 24.1 feet wide & 20.3 feet long, Section 23 & 24, T155N, R68W, N 451046.02, E 2280068.73, elevation 1477.7 @ C/L of bridge, top of wood.

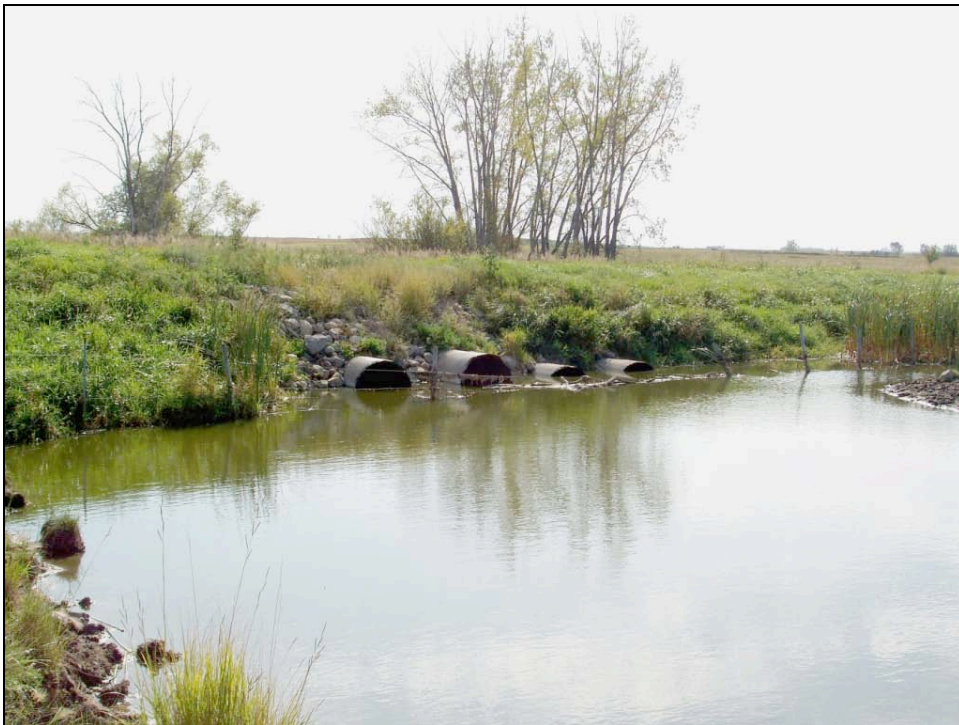
L6 Upstream side of four 48" CMPs in good condition, 2.4 feet, 2.1 feet, 3.4 feet & 3.4 feet of water, from east to west (09-7-05), Section 14 & 23, T155N, R68W, N 453791.66, E 2278875.88, elevation 1470.8 @ invert of 48" CMP, N 453793.23, E 2278868.04, elevation 1471.0 @ invert of 48" CMP, N 453791.97, E 2278858.52, elevation 1469.7 @ invert of 48" CMP, N 453792.04, E 2278850.23, elevation 1469.6 @ invert of 48" CMP.

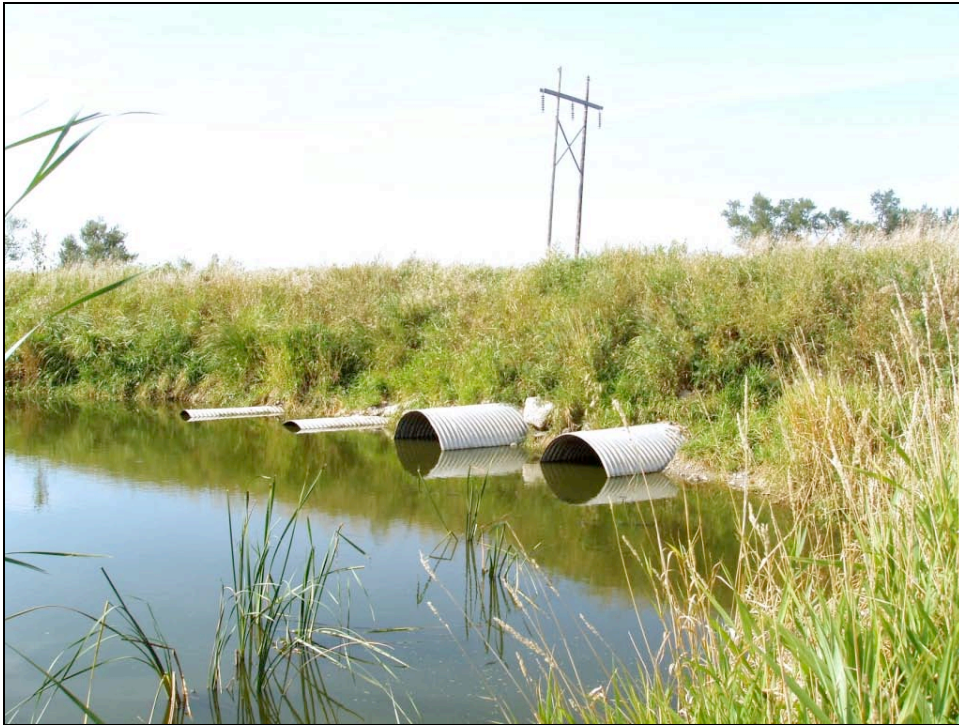
L6 Downstream side of four 48" CMPs in good condition, 2.6 feet, 2.6 feet, 3.8 feet, & 3.8 feet of water, from east to west (09-7-05), Section 14 & 23, T155N, R68W, N 453726.27, E 2278853.47, elevation 1470.4 @ invert of 48" CMP, N 453727.54, E 2278845.16, elevation 1470.4 @ invert of 48" CMP, N 453728.32, E 2278838.03, elevation 1469.3 @ invert of 48" CMP, N 453727.57, E 2278830.79, elevation 1469.2 @ invert of 48" CMP.

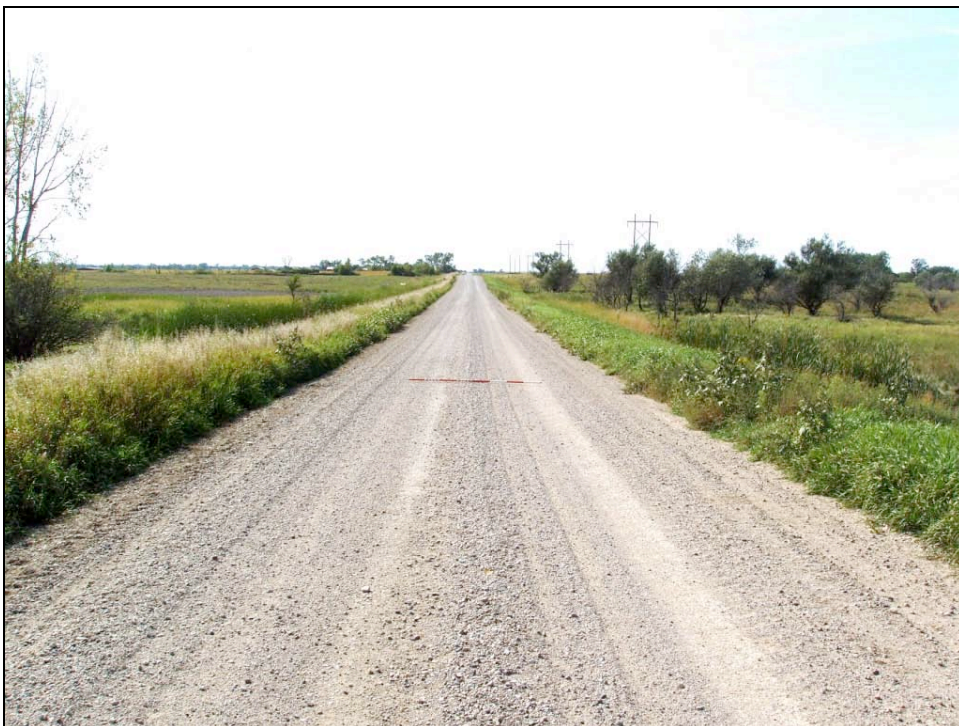
L6 Center of road, across four 48" CMPs, looking west, Section 14 & 23, T155N, R68W, N 453758.90, E 2278855.90, elevation 1479.8 @ center of road crossing, top of gravel.

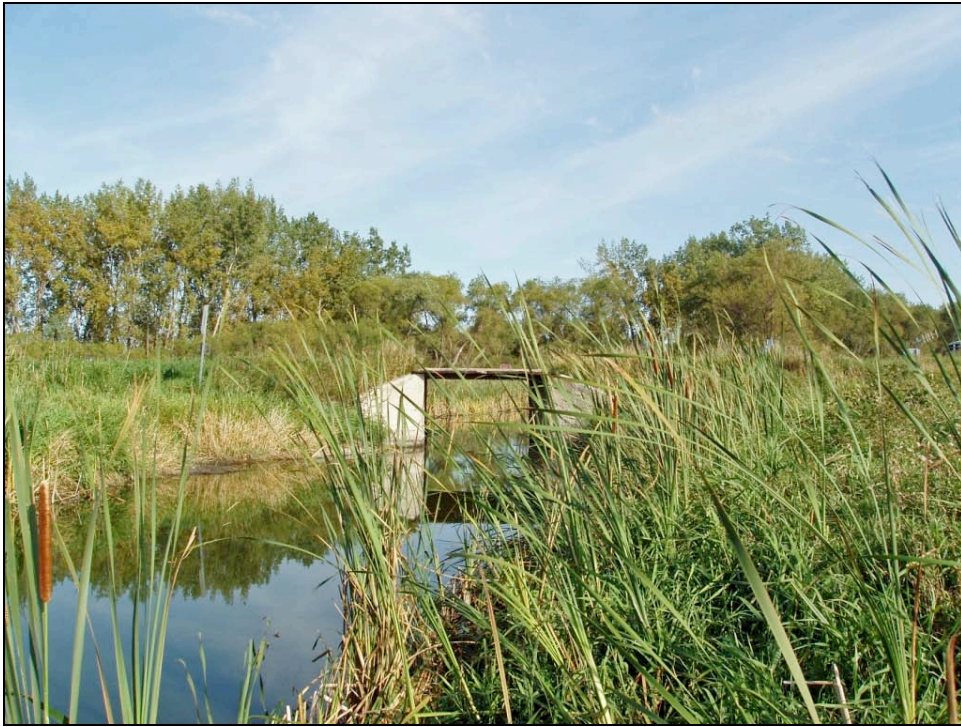
L7 Upstream side of wood & concrete bridge, in fair condition, 1.5 feet of water (09-7-05), Section 15 & 14, T155N, R68W, N 455618.85, E 2274705.52 coulee bottom elevation 1471.4 @ C/L of bridge.

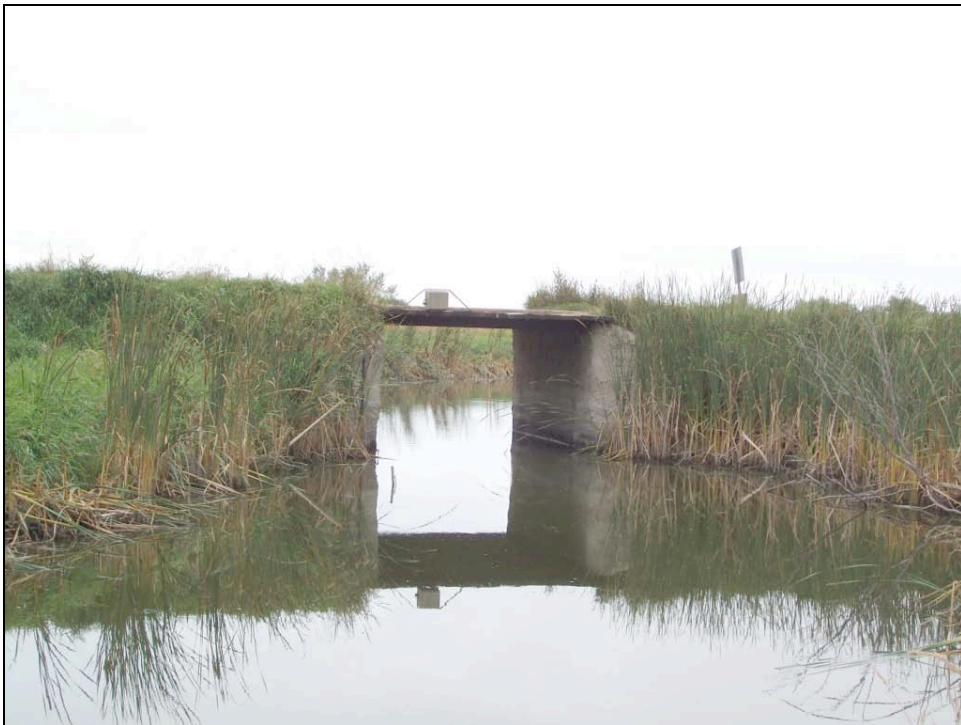
L7 Downstream side of wood & concrete bridge, in fair condition, 1.6 feet of water (09-07-05), Section 15 & 14, T44N, R68W, N 455618.23, E 2274727.74, coulee bottom elevation 1471.2 @ C/L of bridge.

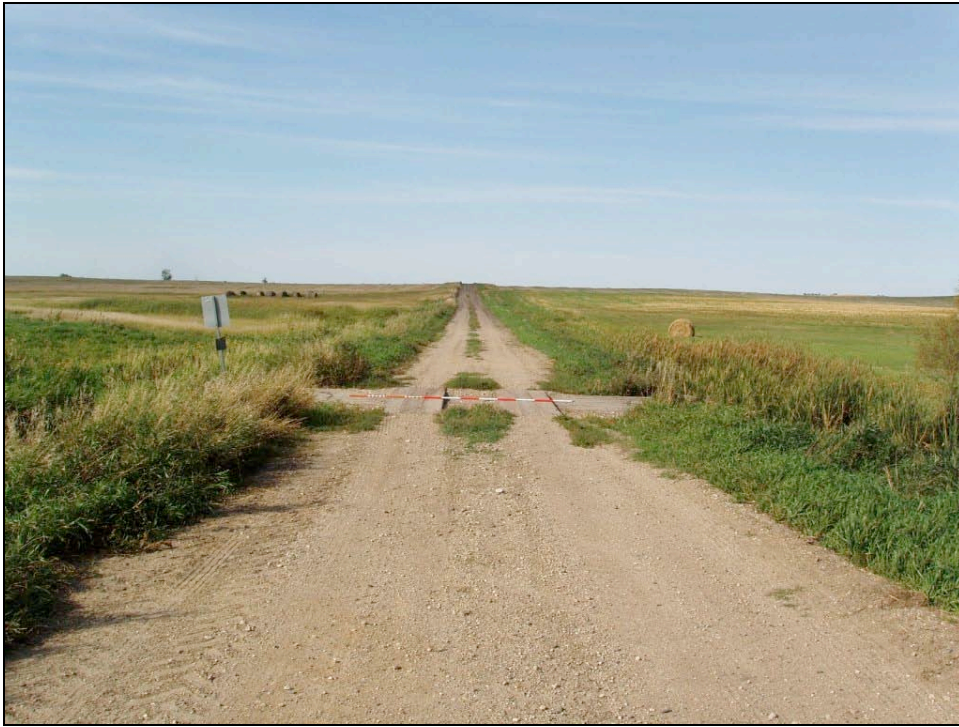
L7 Center of wood & concrete bridge, looking north, in fair condition, 22.3 feet wide & 14.2 feet long, Section 15 & 14, T155N, R68W, N 455618.54, E 2274717.12, elevation 1480.3 @ C/L of bridge, top of wood.

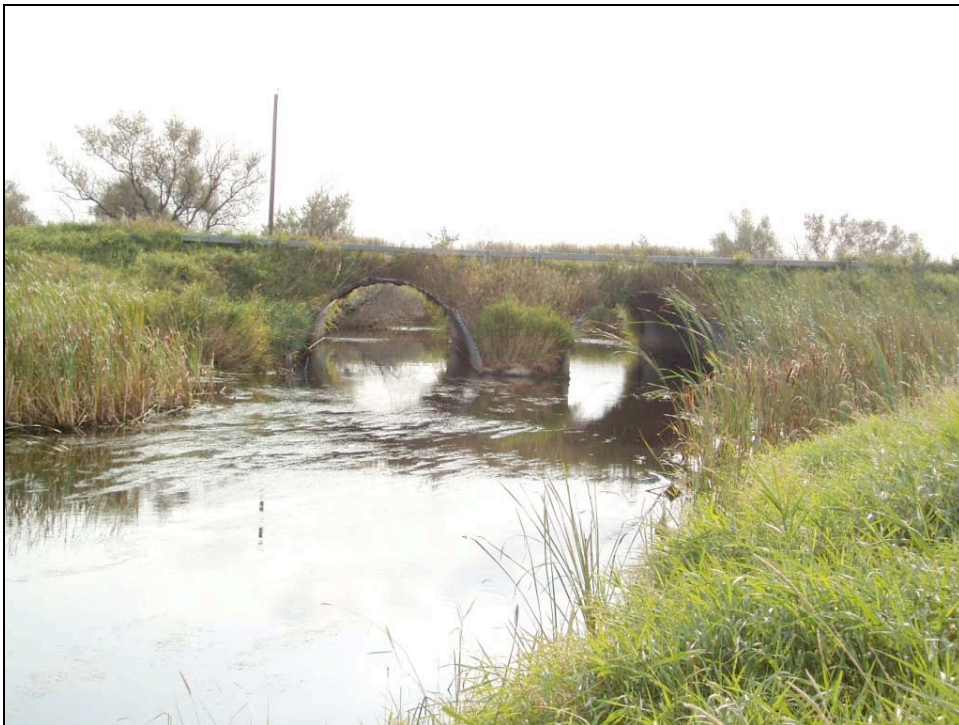
L8 Upstream side of two 108" CMPs, in good condition, 2.1 feet & 2.0 feet of water, from south to north (09-8-05), Section 31 & 32 T156N, R68W, N 469486.70, E 2258651.77, elevation 1473.3 @ invert of 108" CMP, N 469507.63, E 2258652.13, elevation 1473.5 @ invert of 108" CMP.

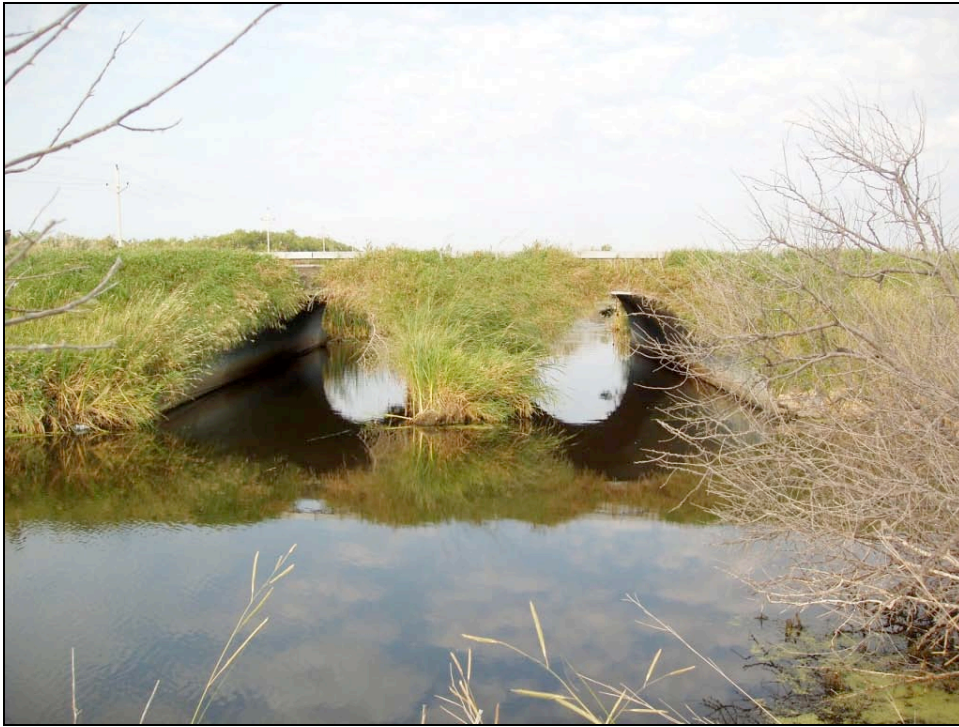
L8 Downstream side of two 108" CMPs, in good condition, 2.1 feet & 2.0 feet of water, from south to north (09-8-05), Section 31 & 32 T156N, R68W, N 469486.45, E 2258681.85, elevation 1473.5 @ invert of 108" CMP, N 469507.37, E 2258681.67, elevation 1473.5 @ invert of 108" CMP.

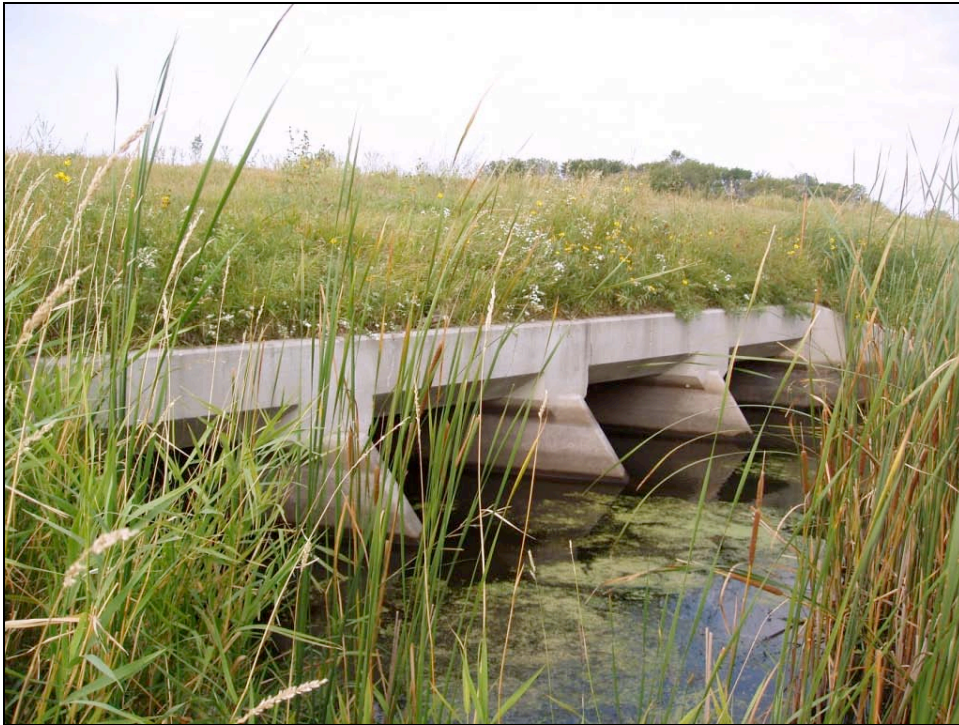
L9 Upstream side of four cell 5 foot Box Culverts, in good condition, 2.2 feet, 2.2 feet, 2.2 feet, & 2.2 feet of water, from east to west (09-8-05), Section 31, T156N, R68W, N 471377.17, E 2256277.40, elevation 1473.4 @ invert of 5' Box Culvert, N 471382.41, E 2256271.74, elevation 1473.4 @ invert of 5' Box Culvert, N 471387.33, E 2256266.51, elevation 1473.4 @ invert of 5' Box Culvert, N 471392.64, E 2256261.15, elevation 1473.4 @ invert of 5' Box Culvert.

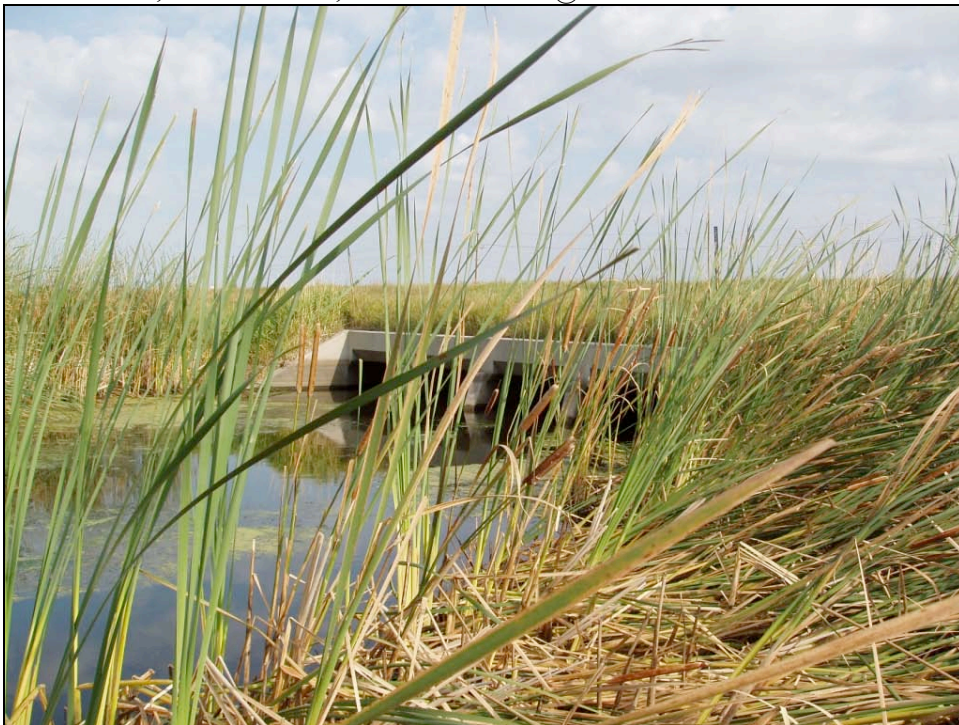
L9 Downstream side of four cell 5 foot Box Culverts, in good condition, 2.4 feet, 2.4 feet, 2.4 feet, & 2.4 feet of water, from east to west (09-8-05), Section 31, T156N, R68W, N 471163.15, E 2256234.82, elevation 1473.1 @ invert of 5' Box Culvert, N 471168.51, E 2256229.10, elevation 1473.1 @ invert of 5' Box Culvert, N 471173.92, E 2256223.45, elevation 1473.2 @ invert of 5' Box Culvert, N 471179.26, E 2256217.86, elevation 1473.1 @ invert of 5' Box Culvert.

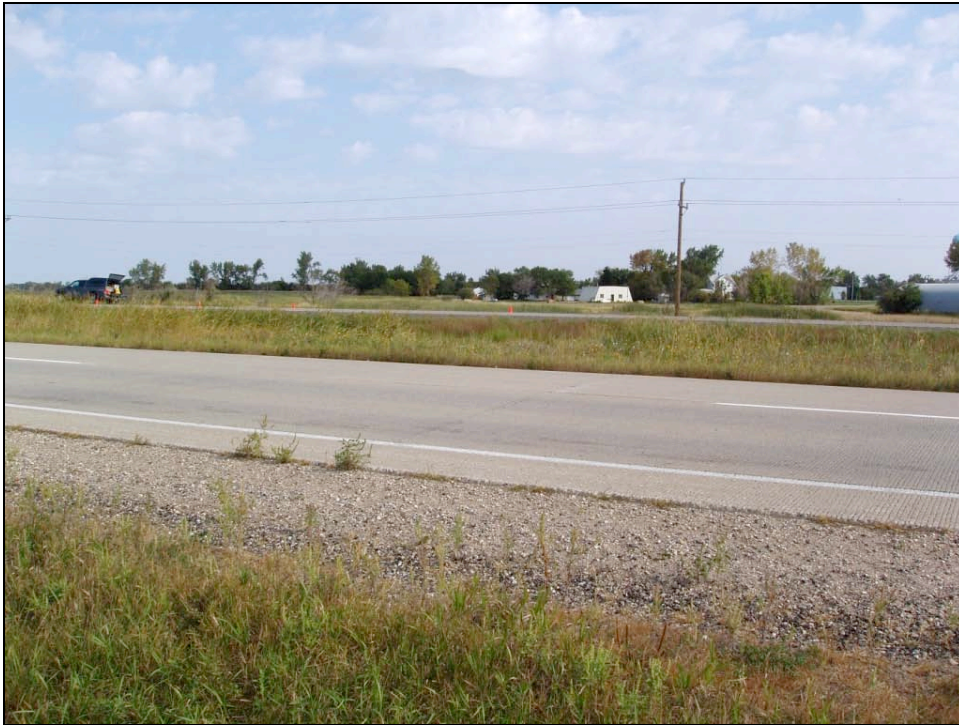
L9 Center of highway crossing, across four 5 foot box culverts, 31 feet long & 218 feet wide, looking north/west (09-8-05), Section 31, T156N, R68W, N 471219.70, E 2256235.64, elevation 1483.4, & N471336.09, E 2256259.95, elevation 1484.4 @ center lanes of Highway 2 crossings, above centers of box culvert, center of south two lanes, then center of north two lanes.

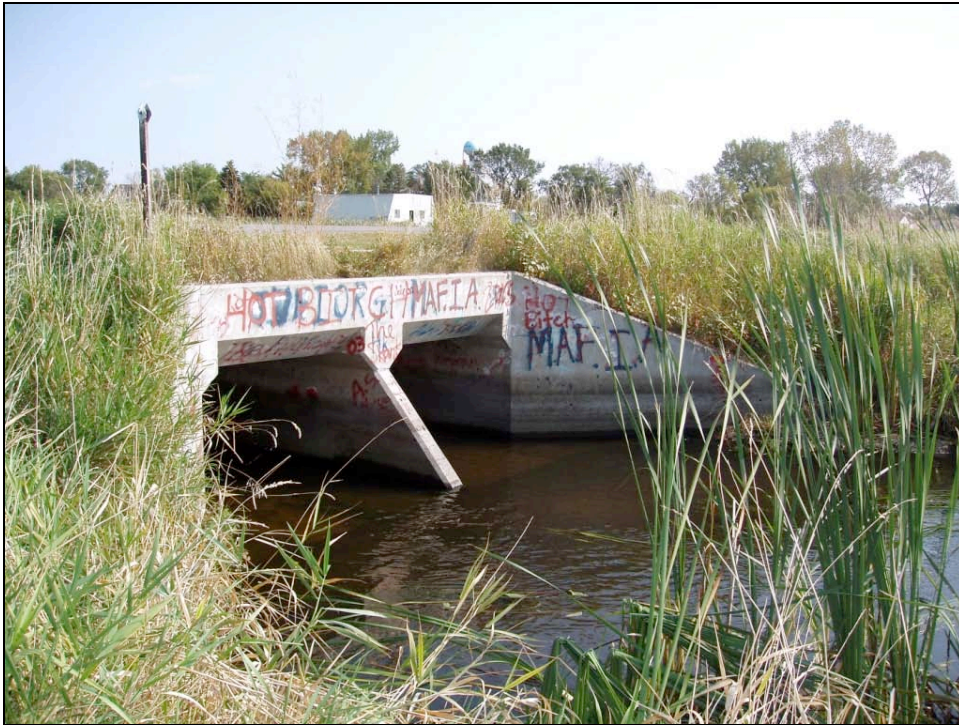
L10 Downstream side of two cell 5 foot box culverts, 13.5 feet long & 66.0 feet wide, in good condition, 0.7 feet, & 0.6 feet of water @ 2 cell box culvert, (09-8-05), north to south Section 32, T156N, R68W, N 471857.32, E 2256206.68, elevation 1475.3 @ invert of 66' Box Culvert, N 471857.58, E 2256200.52, elevation 1475.2 @ invert of 66' Box Culvert.

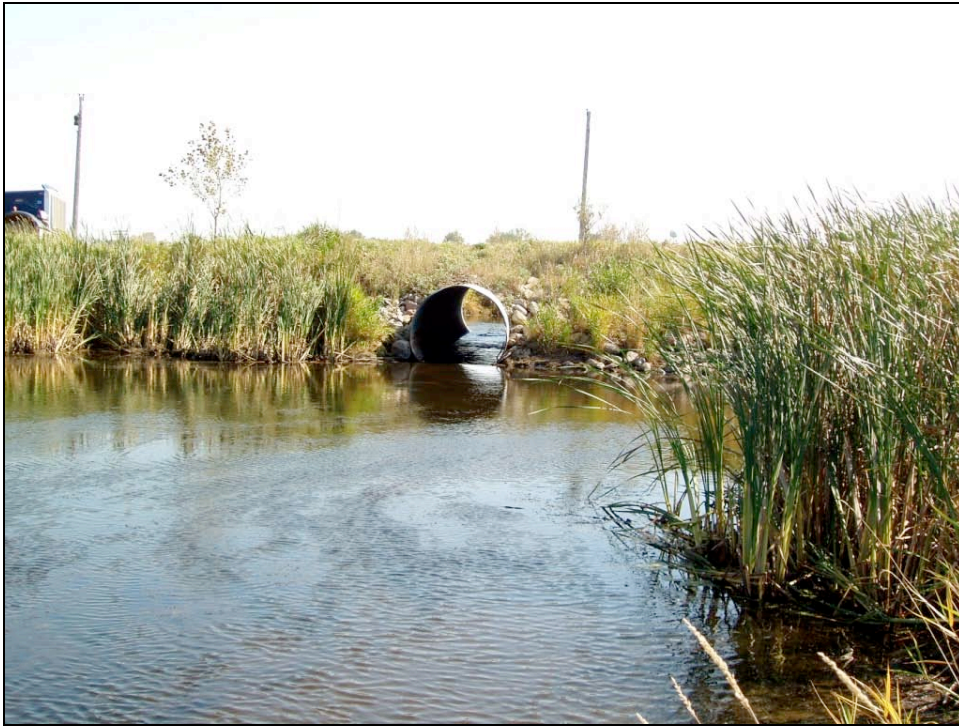
L11 Upstream side of two 72" CMPs, in good condition, 1.2 feet, & 0.7 feet of water, from north to south (09-8-05), Section 36 & 31, T156N, R69 & 68W. N 473367.14, E 2253426.34, elevation 1478.0 @ invert of 72" CMP, N 473332.00, E 2253426.64, elevation 1478.6 @ invert of 72" CMP.

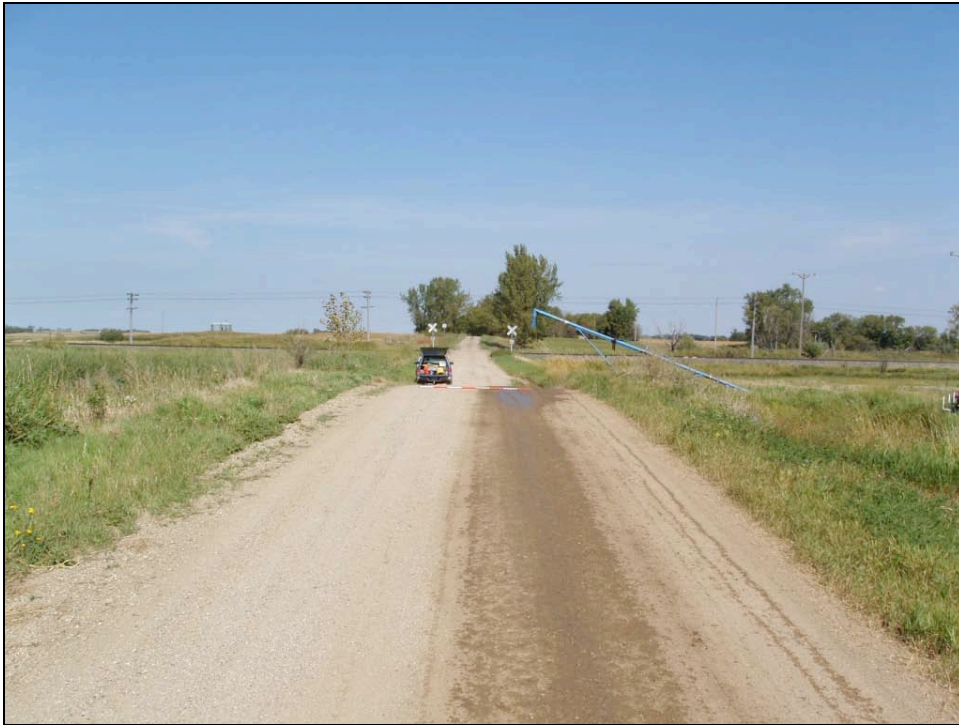
L11 Center of road crossing across two 72" CMPs, looking north, Section 36 & 31, T156N, R69 & 68W, N 473345.07, E 2253453.02, elevation 1486.8 @ center of road crossing, above CMPs, top of gravel.

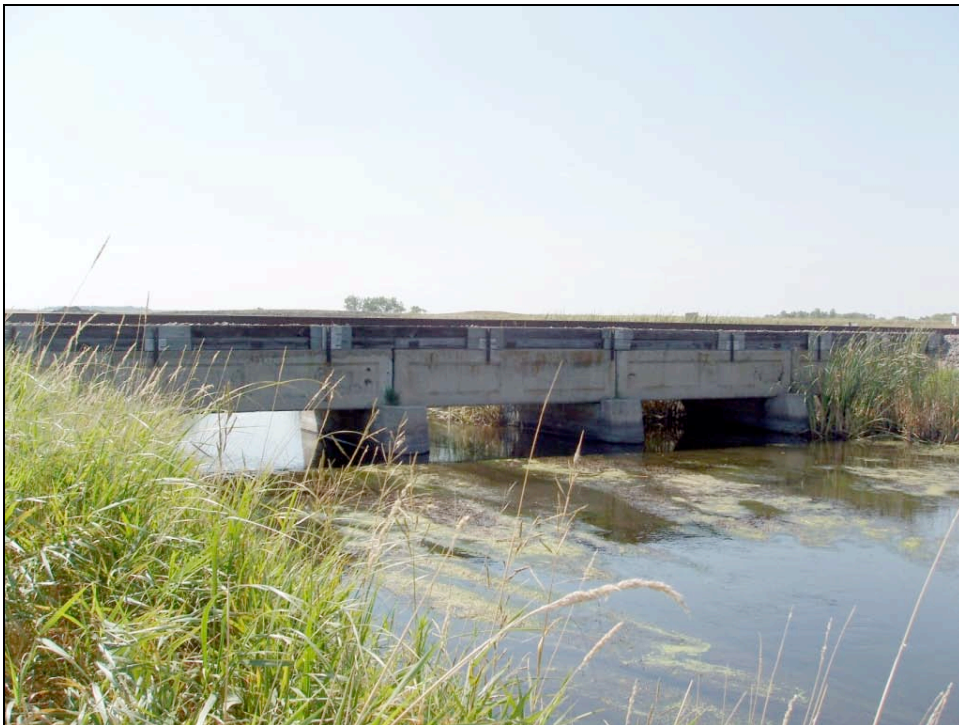
L12 Upstream side of wood & concrete railroad bridge, in good condition, 1.8 feet of water (09-8-05), Section 36, T156N, R69W, N 473704.56, E 2253220.12, coulee bottom elevation 1478.1 @ C/L of bridge.

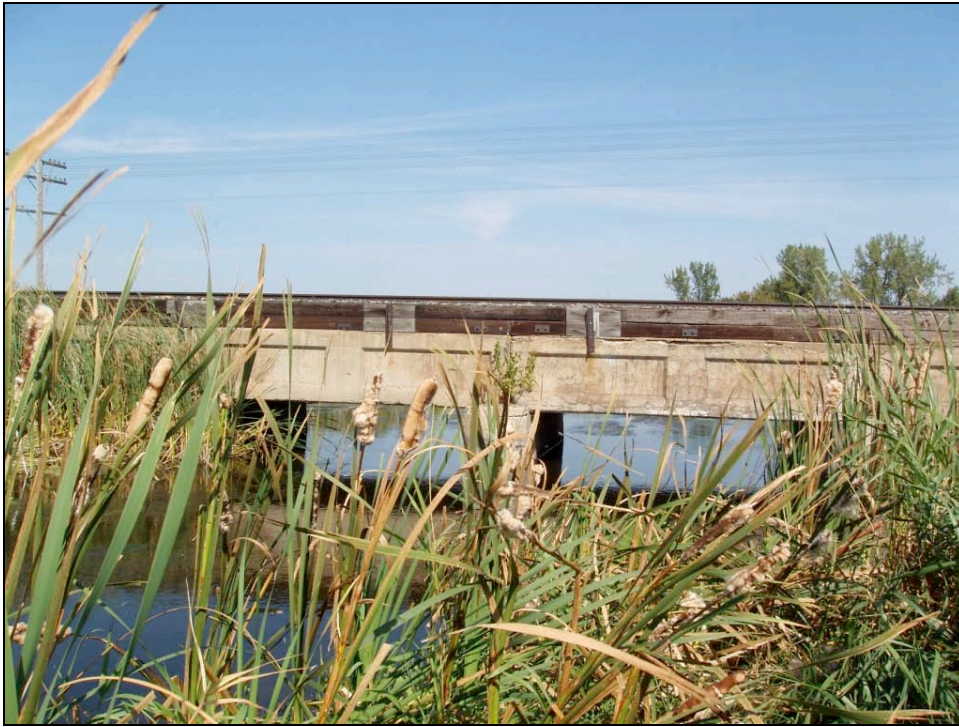
L12 Downstream side of wood & concrete railroad bridge, in good condition, 1.6 feet of water (09-8-05), Section 36, T156N, R69W, N 473692.37, E 2253218.88, coulee bottom elevation 1478.5 @ C/L of bridge.
